IMPORTANT PRODUCT INFORMATION

Product: Upgrade Kit for PACSystems™ RX7i CPUs

IC698CPE010-CD (300 MHz), Firmware Version 1.63

IC698CPE020-CD (700 MHz), Firmware Version 1.63

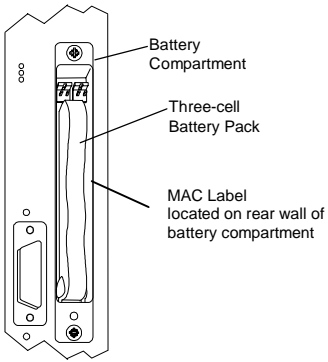
Subject	Description
MAC address	<p>A label on the rear wall inside the CPU's battery compartment identifies the MAC address assigned to the CPU's embedded Ethernet Interface. The label is visible when the battery is removed from its compartment. (The battery does not need to be disconnected to temporarily remove it from the compartment.)</p>

<p>The diagram shows a vertical battery compartment. At the top is the 'Battery Compartment' cover. Below it is a 'Three-cell Battery Pack'. On the rear wall of the compartment, there is a 'MAC Label'.</p>
Configuration of IP Address is Required Before Using Ethernet Communications	<p>The Ethernet Interface within the CPU module cannot operate on a network until a valid IP address is configured. The necessary Ethernet addressing information must be configured prior to actual network operation, or to recover from inadvertent changes to the Ethernet addressing data at the Ethernet Interface. Use one of the following methods to initially assign an IP address:</p> <ul style="list-style-type: none"> ■ Connect a serial terminal to the Station Manager port of the PACSystems RX7i . Then use the CHSOSW command to enter the desired IP address. For details, see <i>Station Manager for the PACSystems RX7i</i>, GFK-2225. ■ Temporarily assign an IP address to the module using the SetIP tool over the Ethernet network. For details, see <i>TCP/IP Ethernet Communications the PACSystems</i>, GFK-2224. ■ The Ethernet Interface automatically obtains a temporary IP Address from a BOOTP server on the network. For details, see <i>TCP/IP Ethernet Communications for PACSystems</i>, GFK-2224. <p>Once a temporary IP address has been set up, the Ethernet Interface can be accessed over the network (such as by the CIMPLICITY ME programming software). The programmer should then be used to configure the proper IP address for the Ethernet Interface.</p>
